St Mary's Church, Woodstock, Oxon

11 February 2022

Roofing Report

Jeremy Bell B.Arch. M.Ed. RIBA

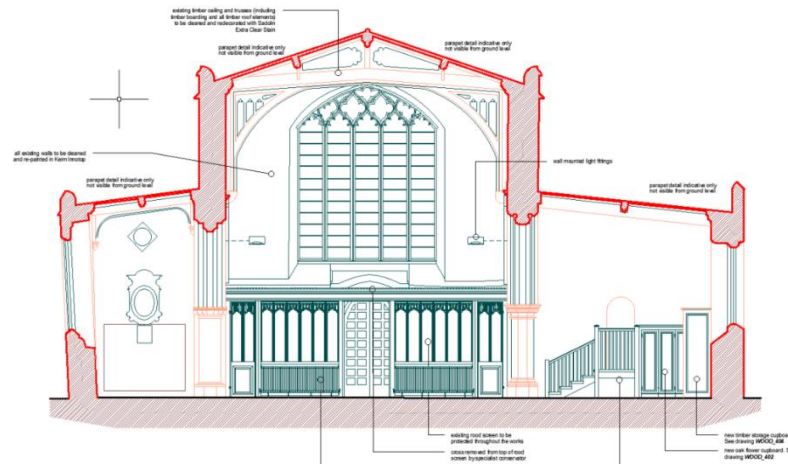
Cross Section NTS

The adjacent cross section indicates the roof configuration. The slope of the roof is 18 degrees, which is sufficient for a lead roof. The problem is that lead sheeting should not be laid in a continuous length without a “drip”, that is a step to break the length of the lead sheet and allow it to expand and contract with temperature.

Only on the South Aisle face would the sheet length come close to Code 6 lead sheet maximum length. On the North Aisle and the Nave the single sheets of lead exceed permitted length considerably.

South Aisle, 2364mm
Nave per side, 3752mm
North Aisle, 4353mm

Permitted length 2250mm
Permitted length 2250mm
Permitted length 2250mm

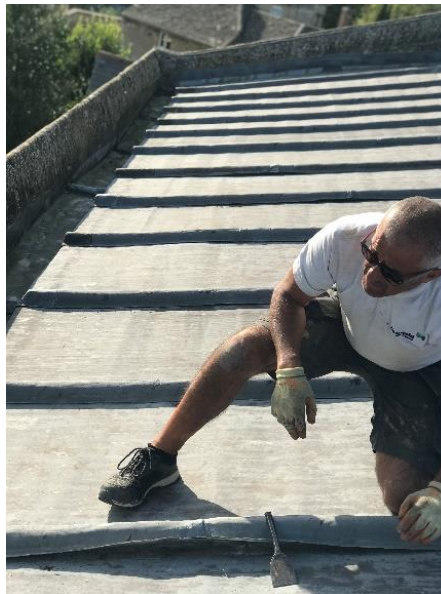
Photo 1

Workmen in the process of lifting one of the lead rolls on the South Aisle.

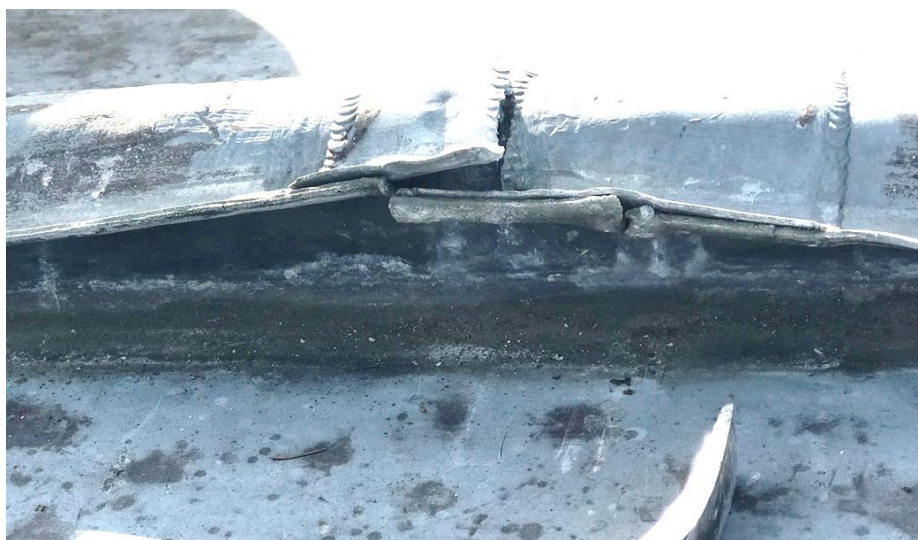
Photo 2

This photograph shows the damage to lead roll under the cover-roll, and how the cover-roll has been soldered twice in the same region.

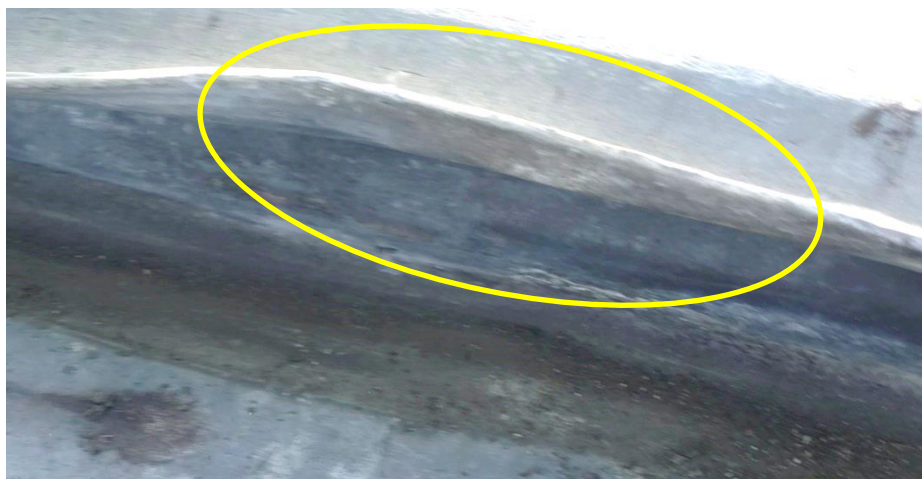
Photo 3
This photograph shows typical problems of in-line cracking in the lower rolls of the lead, beneath the cover-rolls

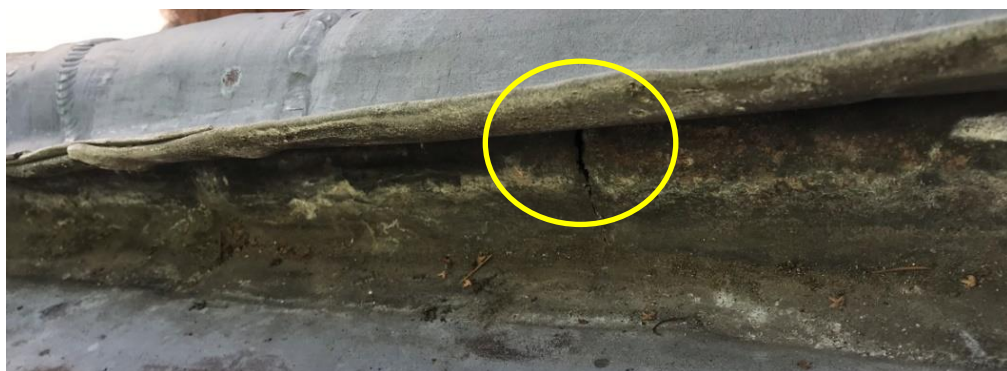
Photo 4
A further photograph showing transverse cracking in the lower lead roll.

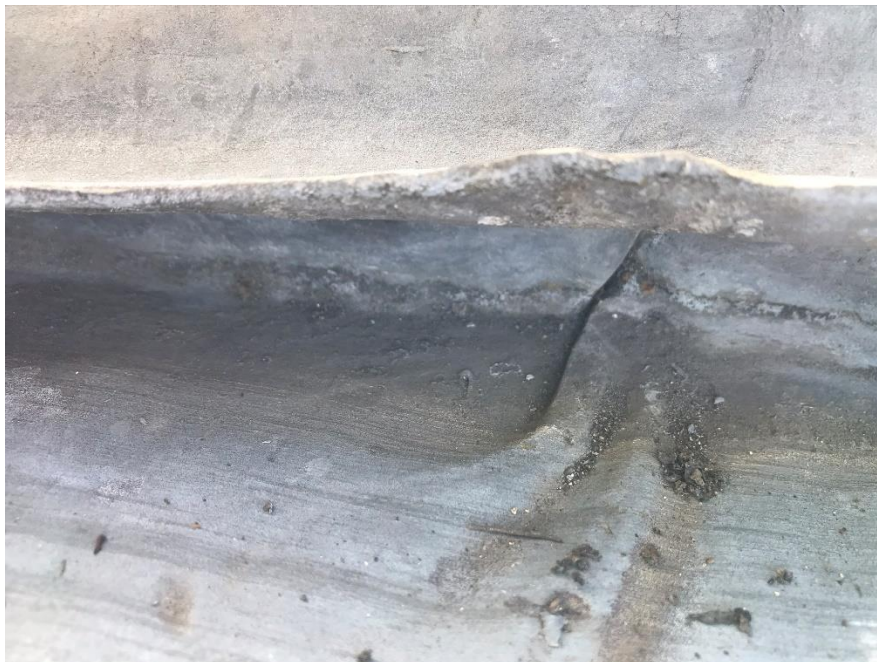
Photo 5

This photo shows two typical problems. First is the ripple in the lead caused by excessive expansion. The second is the cracking caused by the same reason. Attempted repairs are evident.

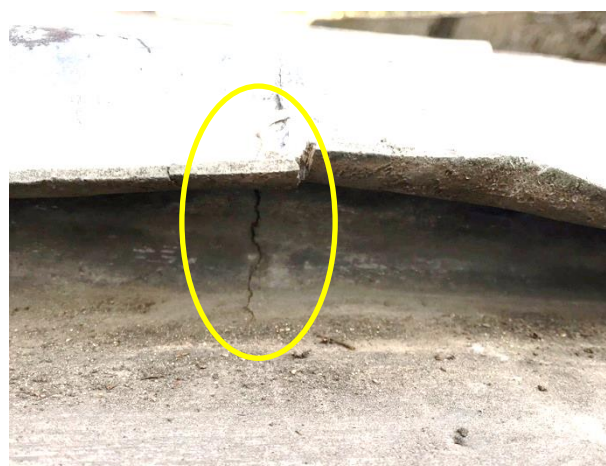
Photo 6

Here another crack can be seen transverse to the line of the roof sheets, caused by expansion and contraction stresses.

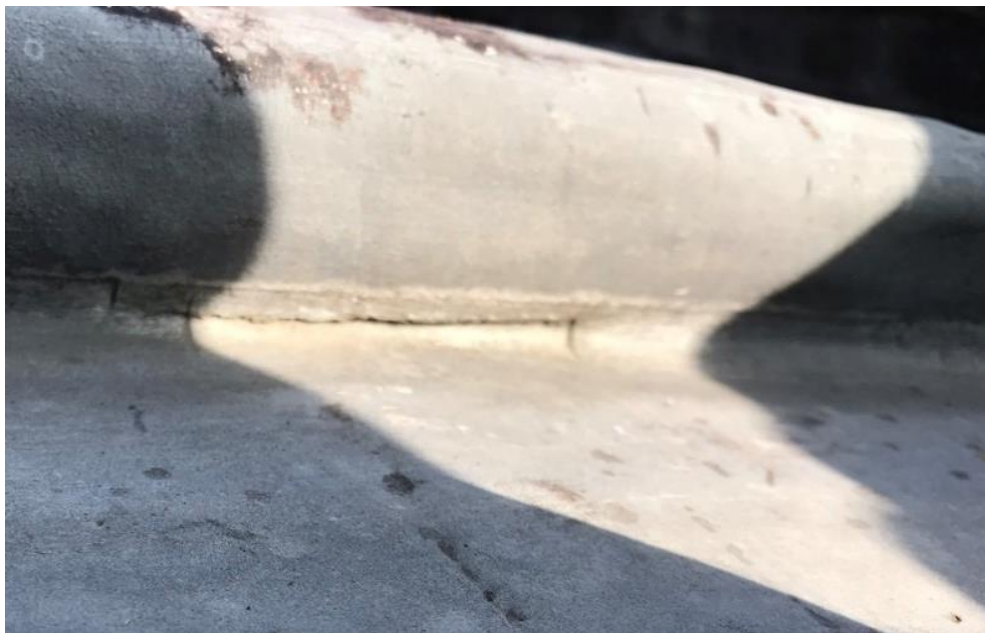
Photo 7
This photograph shows a typical in line crack in the cover-roll indicating the weakness of the lead along the fold line, and that it is fixed from movement by the roll

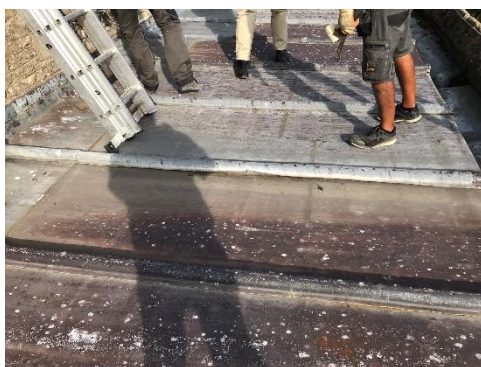
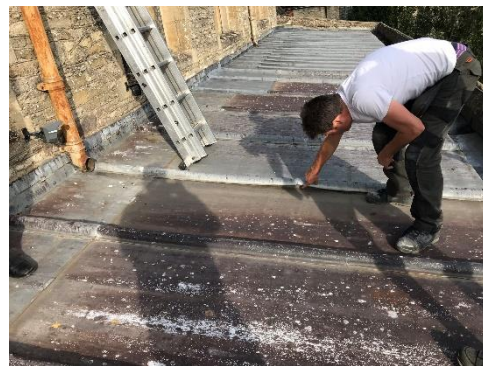
Photos 8 and 9
Typical illustration of a lead roll that looks in good condition. However after lifting it up, there is a crack about mid way along the lead sheet.

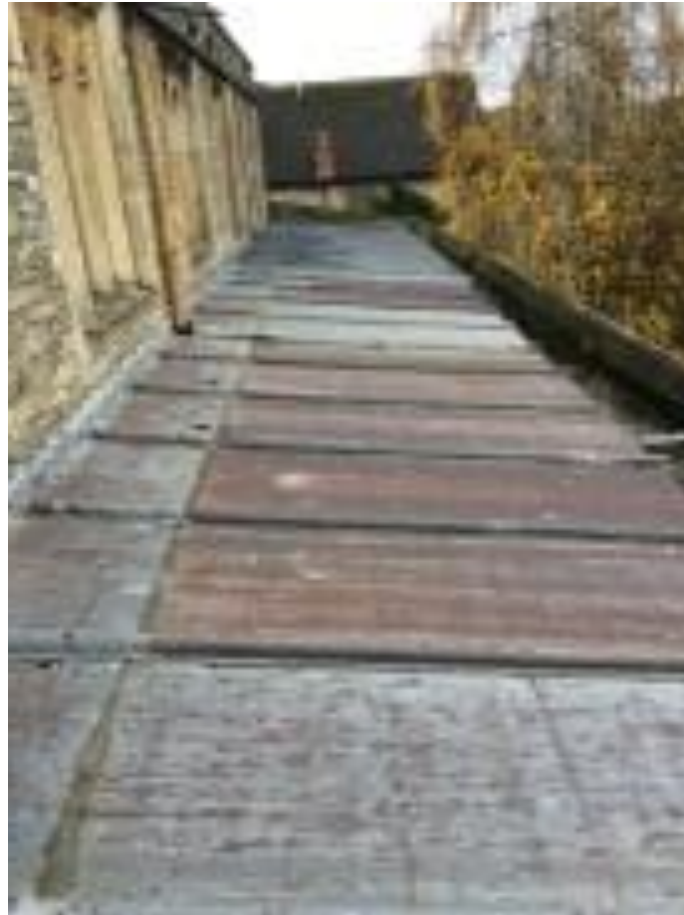
Photo 10

The reason for the cracks in the roof.

This photograph shows the lead cover strip at the top of the slope covering the hanging fixings at the head of the slope. The single sheet length has been measured excluding 300mm at the head of the pitch, below the lap of the cover strip. Also 300mm has been deducted from the overall dimension of the total length from parapet to south wall, for the width of the valley gutter. Even so, the single sheet length is 2364mm whereas the permitted length is 2250mm

Even though this is close to the recommended length, the roof slope faces due south, and gets the heat of the sun in full force, as well as the coolness of night time and shadow periods.

There is insufficient provision for expansion and contraction and as a result there is cracking in the lead sheet, where it gives way. These are primarily in places where the lead has been kinked, to be dressed up and over the wooden rolls, or along the lead rolls.

The reason the cracks occur across the lead rolls, or across the sheets, is that the length of the sheets cannot accommodate the expansion and contraction stresses.

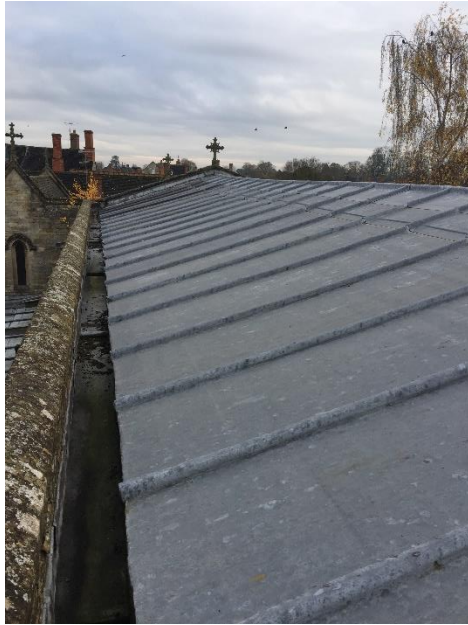
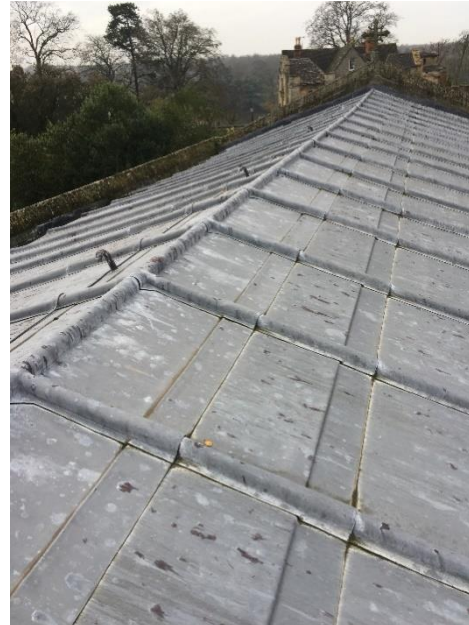
Photos 11 and 12

The Nave Roof, showing the north face and the ridge. The two strips on the south side, are probably fixing locations in narrower substrate boards, so that the lead over sheet covers them.

Even discounting the length of the fixing locations and allowing for the reduction of length of the lower section sheets as against the total overall pitch length, the sheet lengths are 3752mm when they are recommended to be 2250mm. The sheets are 40% longer than recommended.

There are leaks in this section of the roof.

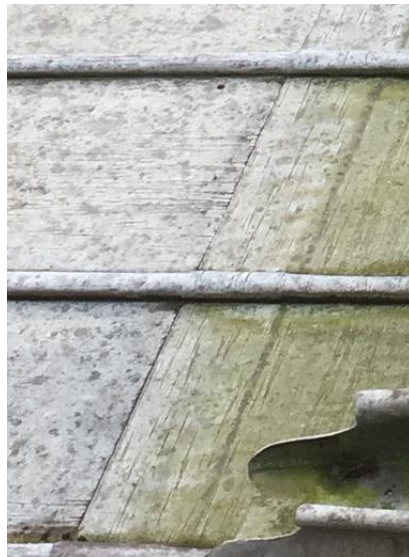
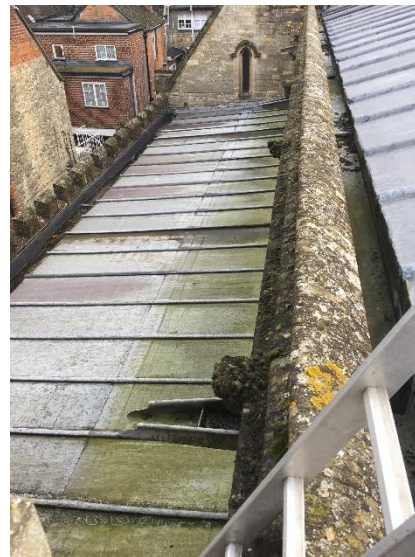
Photos 13 and 14

The North aisle roof.

These photos show an overall picture of the north aisle roof, and a detail of the line along the length of the roof slope, where there is cracking and damage along the line of what appears to be one particular lay-board.

This roof face is the worst case of exceeding the recommended length of the lead roof sheets. Discounting a margin for fixing and guttering, the lead sheet length is 4353mm, when it is recommended to be 2250mm. In this case the sheets are 48% longer than recommended.

This is the north face, and the least vulnerable to excessive sunshine or driving rain, and it appears to be just holding out, because at present there are no known leaks in the north aisle. On the other hand the roof sheeting appears to be in the worst condition, and it is only a matter of time when the long surface crack penetrates the full depth of the lead sheet and causes a series of leaks along the roof slope.
