St Mary's Church, Woodstock, Oxon

11 February 2022

Roofing Report

Jeremy Bell B.Arch. M.Ed. RIBA

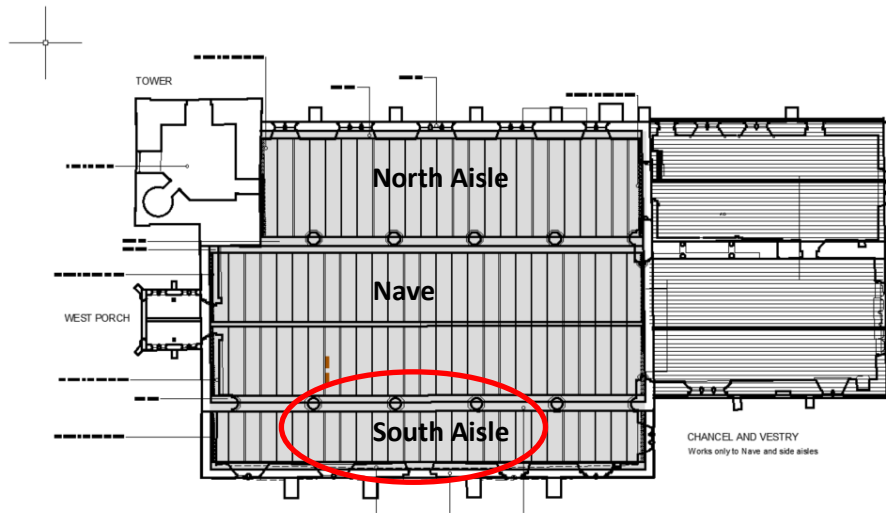
Roof Plan NTS

The adjacent roof plan shows the 4 parts of the church. Tower, Porch, Nave and Side Aisles, and Chancel and Vestry area.

This report is primarily about the leaded part of the roof, the Nave and Side Aisles.
